PISCATAQUA RIVER BASIN
NOTTINGHAM, NEW HAMPSHIRE

DOLLOFF DAM
NH 00134

PHASE I INSPECTION REPORT
NATIONAL DAM INSPECTION PROGRAM

JULY 1978

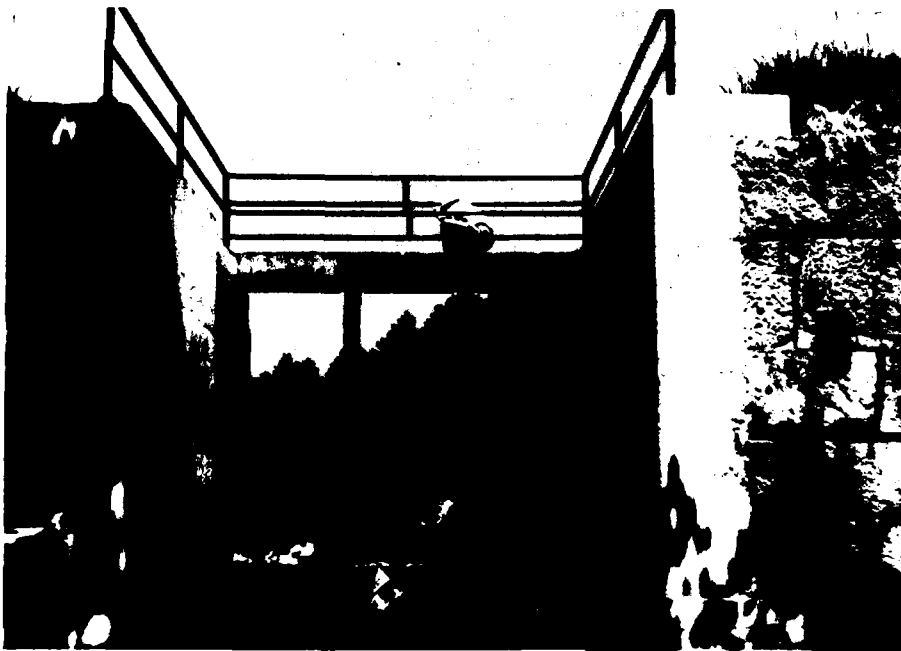
The lake level is primarily maintained by a 13'-4" wide by 11' - 7" high removable stoplog section located approximately 100 feet from the left abutment. (See Appendix C - Figure 9.) The wood stoplogs appeared in good condition, however, numerous leaks were noted. The stoplogs were leaking at the joints between the planks and at the seats between planks and vertical supports. The two center steel uprights have not been painted and are showing evidence of corrosion. Leaching and wet spots were observed at least in five concrete form tie-holes up to 3 feet above the channel bottom. A hairline crack was visible in the left channel wall located below the service bridge in the top third of the wall. The crack was dry at the time of the inspection and showed no evidence of previous leakage. Minor spalling of concrete was observed at the base of the left side wall near the downstream corner. (See Appendix C - Figure 10.) Minor seepage

Figure 9 - Looking upstream at the stoplog spillway at Dolloff Dam.

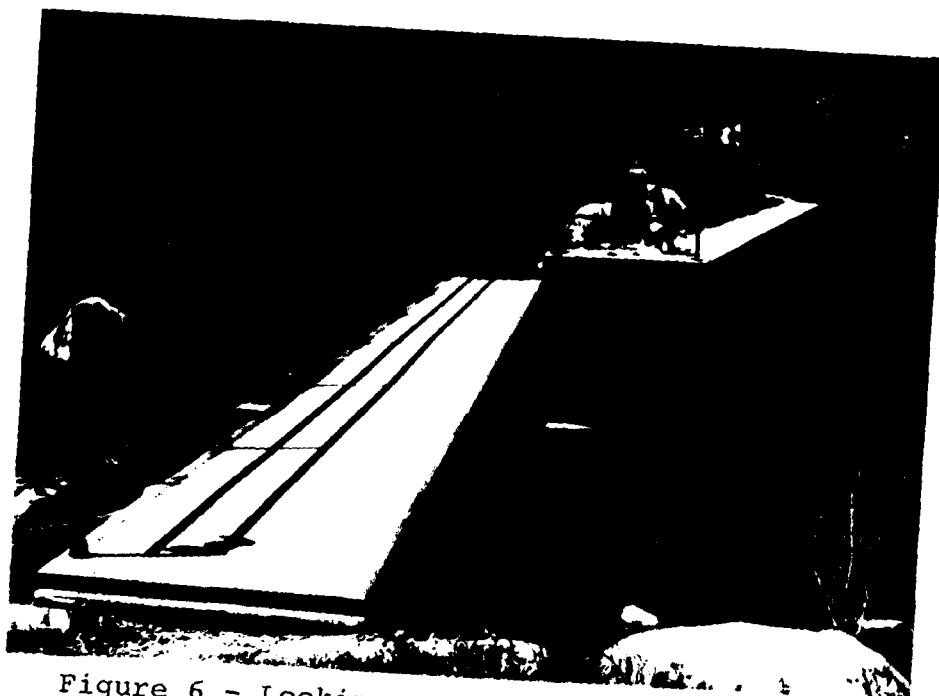
c. Appurtenant Structures. Access to the top of the dam is across a concrete service bridge over the overflow spillway. (See Appendix C - Figure 6.) The bridge consists of two simple spans. The concrete deck is supported in the center with a steel wide-flange beam spaced between the top of a concrete pier and the underside of the deck. (See Appendix C - Figure 7.) The wide-flange beam has not been painted and is rusting. There is a hairline crack through the left deck section at the left abutment. (See Appendix C - Figure 8.) The service bridge railing is painted steel with little evidence of corrosion. The expansion joint in the deck at the center pier is in fair condition and has some evidence of deterioration.

Figure 6 - Looking southwest across the overflow spillway from the northeast abutment.

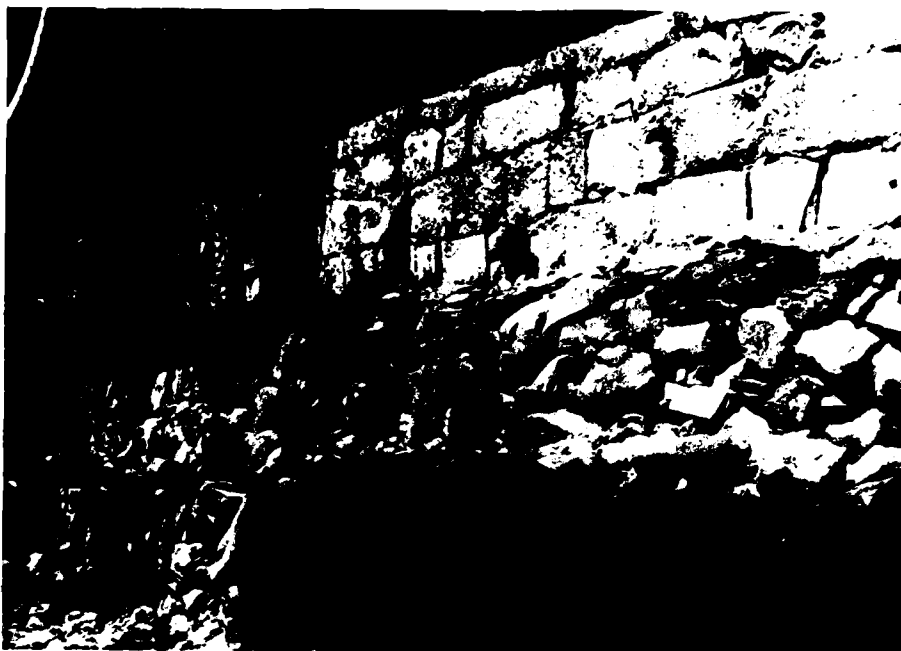
(1) Embankment. Visual observations indicated that some deterioration of the rock berms has occurred on the downstream face of the dam, as evidenced by holes in the top of the uppermost berm at one location and a fallout of rock from the face of the upper berm at a second location. The extent of the deterioration is not considered serious in the present condition, but the stability of the dam would be adversely affected if the deterioration continued. A total of three holes in the berms to the right of the stoplog spillway were noted. A portion of a timber remaining in one of them indicates that they may have been a part of the original construction and that the holes contained large timbers that may have been used as bracing for the main wall. A wet spot was noted near the downstream toe of the dam at one location, and concentrated seepage was discharging at the base on the northeast sidewall of the stoplog spillway. Southwest of the low-level gated outlet, water was discharging from the lowest rock berm at the downstream face of the dam, but it could not be determined that this water was seepage under and/or through the dam or whether it was the result of lateral flow of water from the nearby low-level gated outlet channel.

Some minor bulging and tilt were noted in the top part of the vertical dry masonry wall that is exposed above the rock berms on the downstream face of the dam.

Figure 4 - Looking southwest at the downstream face between gated outlet and southwest abutment, showing the top two berms and the vertical wall.
